Preventing Ice Dams and Associated Problems

Options for Installing NCFI Closed-Cell Spray Polyurethane Foam to Roof Decks

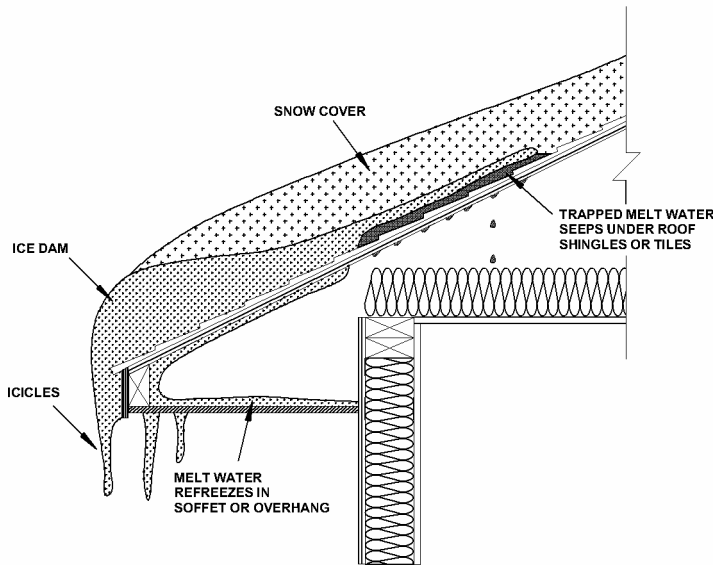
Profile of Typical Ice Dam

When melt water caused by the warm roof deck runs down the roof surface and contacts cold surfaces at the roof edge or at the roof overhang, the water will freeze and ice will accumulate. This accumulation will impede drainage causing the melt water to back up under the roofing shingles or tiles.

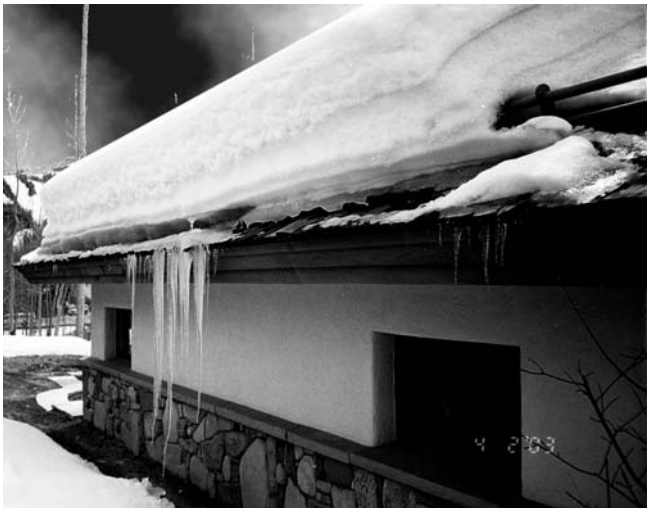
Photo of Typical Ice Dam

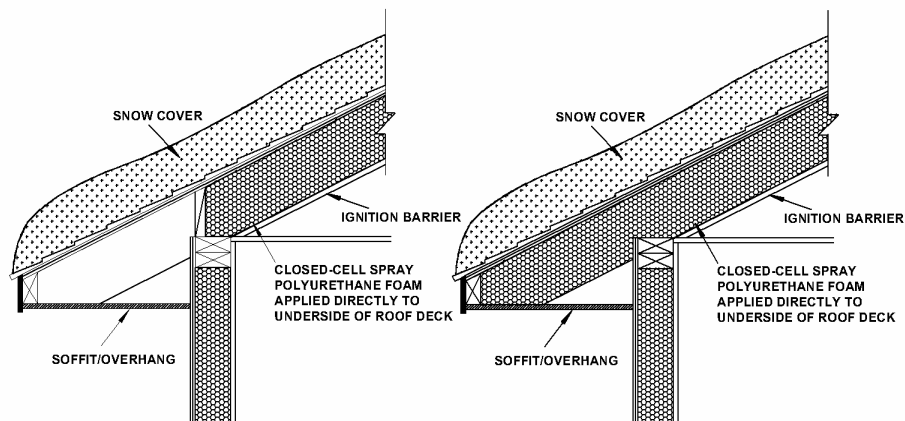
NCFI closed-cell spray polyurethane foam can be utilized to insulate the underside of the roof deck to minimize the conditions under which ice dams form. Properly installed NCFI closed-cell spray polyurethane foam forms a complete air barrier. There are no seams or gaps to allow radiant heat loss or air leakage.

Typical Attic and Cathedral Ceiling Installations
